**Inspection Report**

**Mine Name:** Pandora

**Permit number:** M0370012

**Inspection Date:** January 10,  
2007

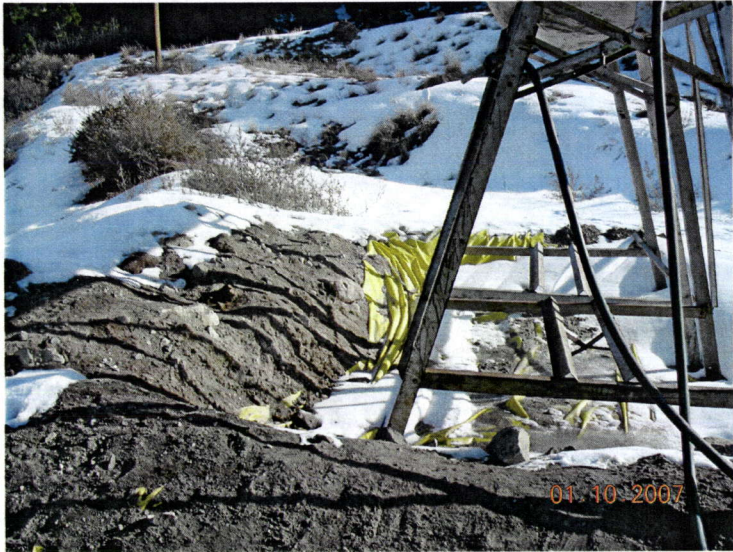
Photo 1

There were two diesel tanks in bermed areas, but the liner in the area with the larger tank did not extend to the top of the berm (Photos 1 and 2). The liner for the other tank was a woven tarp that we would expect to leak (Photos 3 and 4).

The operator needs to ensure appropriate liners are used for the fuel tanks and that they are installed properly.
